### MEMORANDUM

**TO:** Peter Cordingley, Muriel Lake Basin Management Society

- **RE:**Surface Disturbances within Muriel Lake (Alberta) BasinPrepared in accordance with the approved scope of work, dated May 25, 2015
- DATE: November 23, 2015

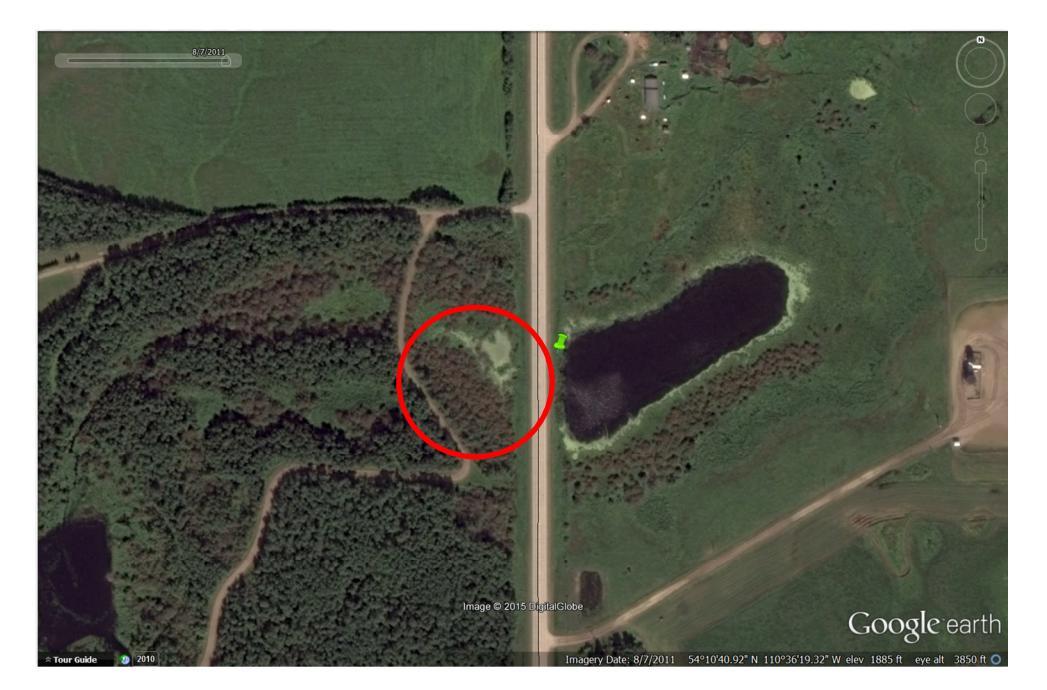
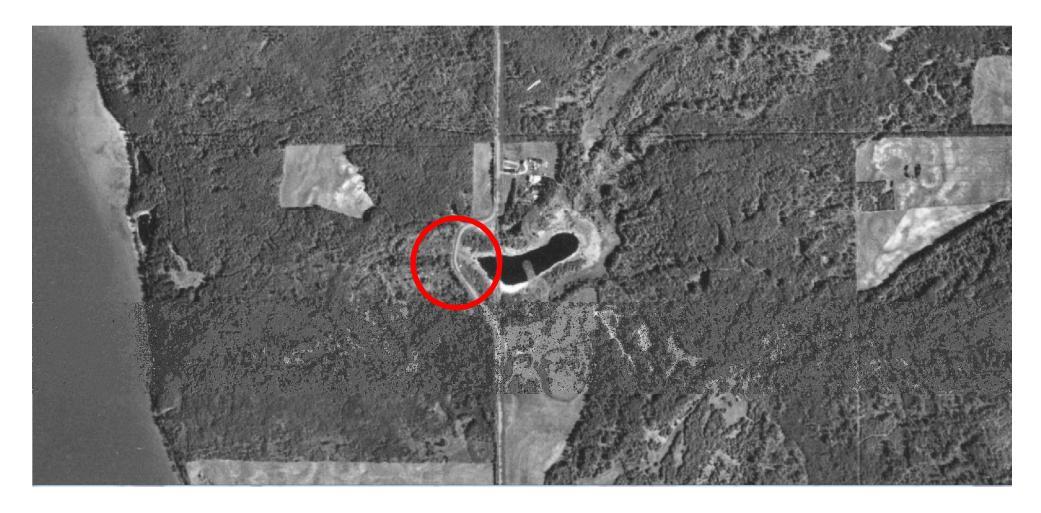
- o Culvert 17: Water body has been split by Hwy 657 between 1959 and 2011 imagery.
- Culvert 15: Open water area is present upstream from this culvert in the 2011 imagery, and is not present in 1972.

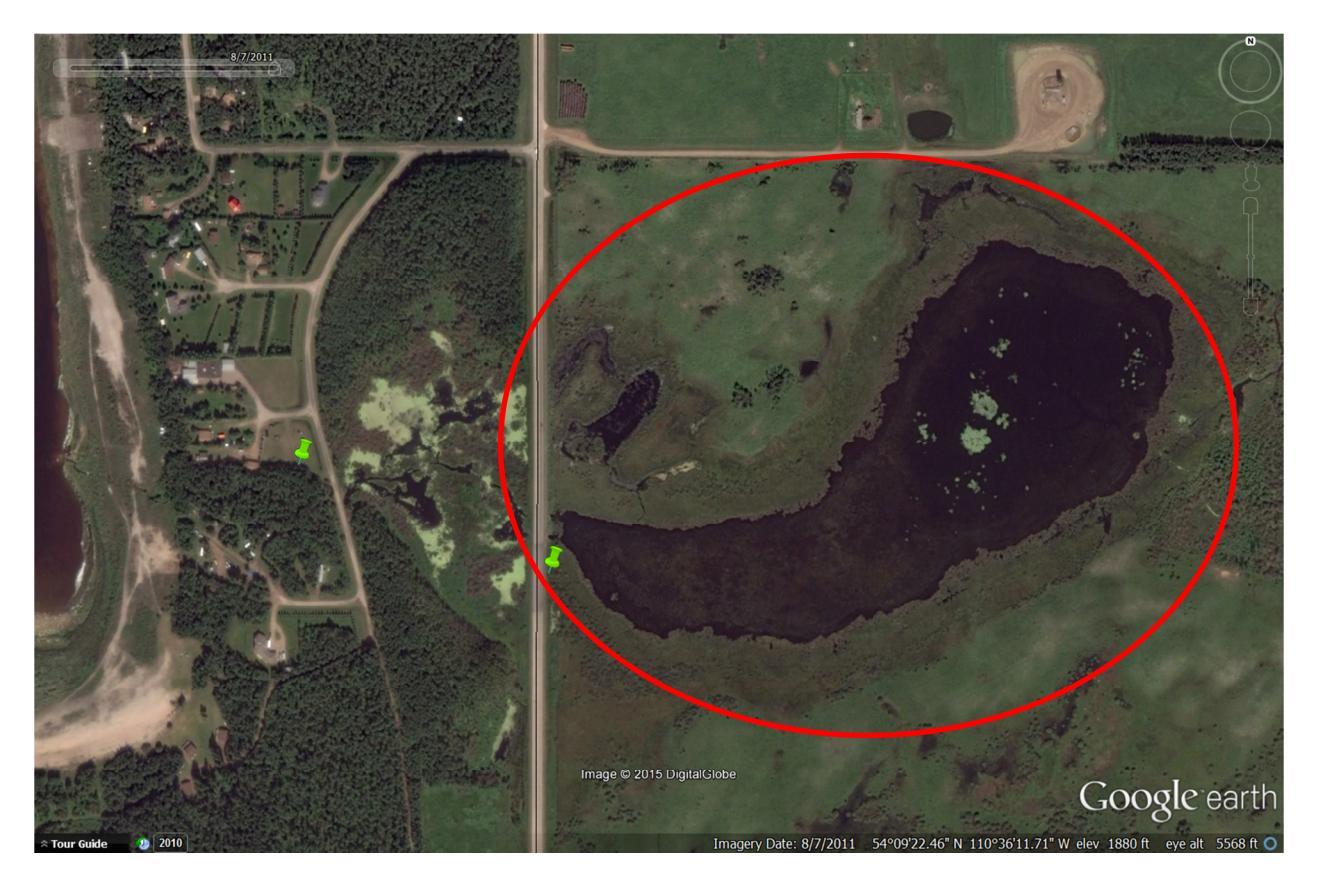
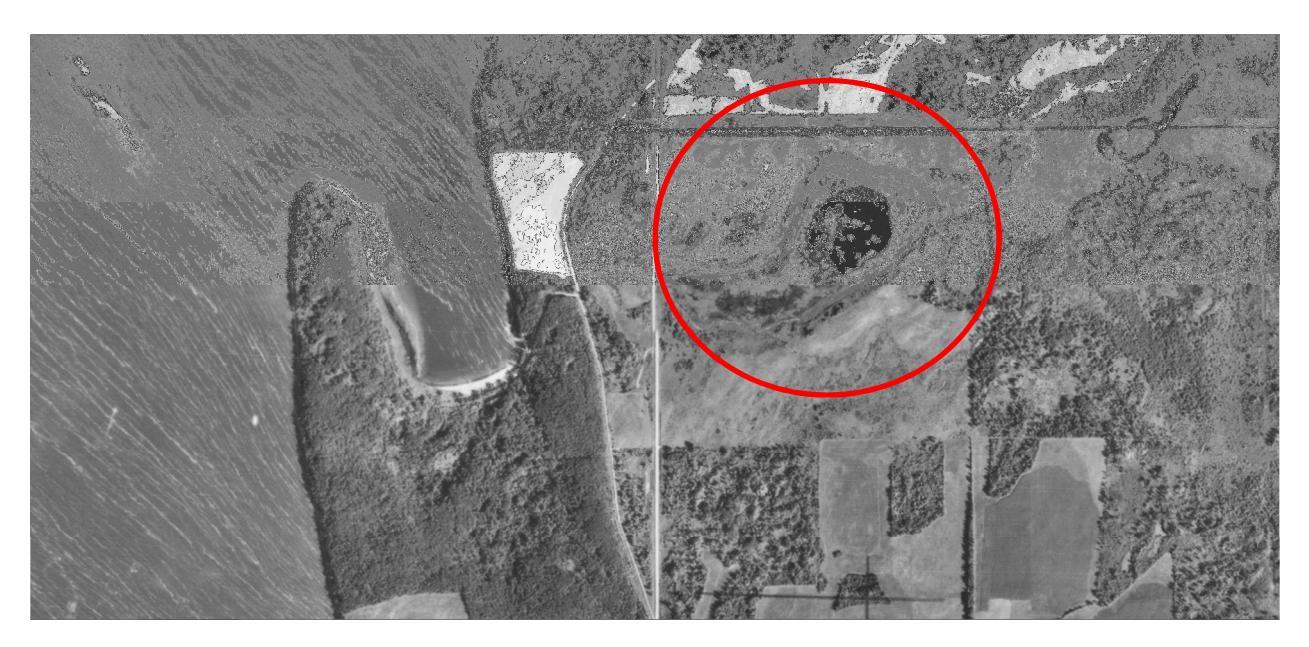
# Culvert 14 and 18

- Culverts 14 and 18: Large water body has formed upstream of culvert 14 in the 2011 imagery. Smaller open water area visible in 1972. Culvert 18 is located downstream of culvert 14 and appears to hydraulically connected.

Culvert		Date of Present	Recommendation		
ID	1959	1972	Present	Imagery	
					possible beaver activity.
18	• No road visible.	<ul> <li>Minimal change from 1959.</li> </ul>	<ul> <li>Culvert is located on a channelized area, downstream of culvert 14.</li> </ul>	August 7, 2011	<ul> <li>Inspect for blocked or perched culvert condition.</li> <li>Note any possible beaver activity.</li> </ul>
13	<ul> <li>No road visible.</li> <li>Low quality imagery.</li> <li>No open water visible upstream or downstream of road.</li> </ul>	<ul> <li>Minimal change from 1959.</li> </ul>	Minimal change from 1959.	August 7, 2011	<ul> <li>No recommendations.</li> </ul>
12	<ul> <li>No road visible.</li> <li>Evidence of open water in upstream area.</li> </ul>	<ul> <li>Minimal change from 1959.</li> </ul>	<ul> <li>Slightly reduced open water on upstream side of road.</li> </ul>	August 7, 2011	<ul> <li>No recommendations.</li> </ul>

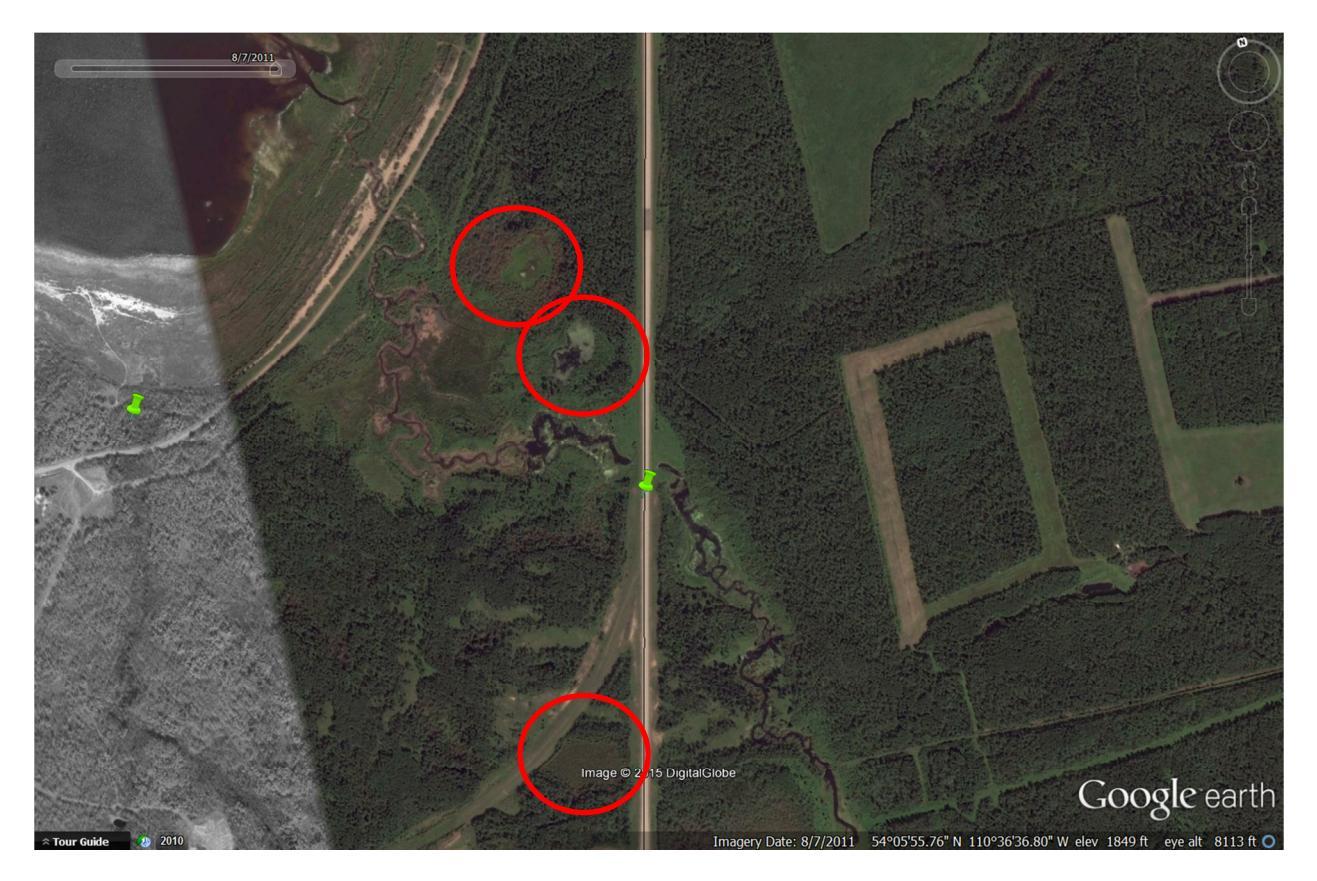
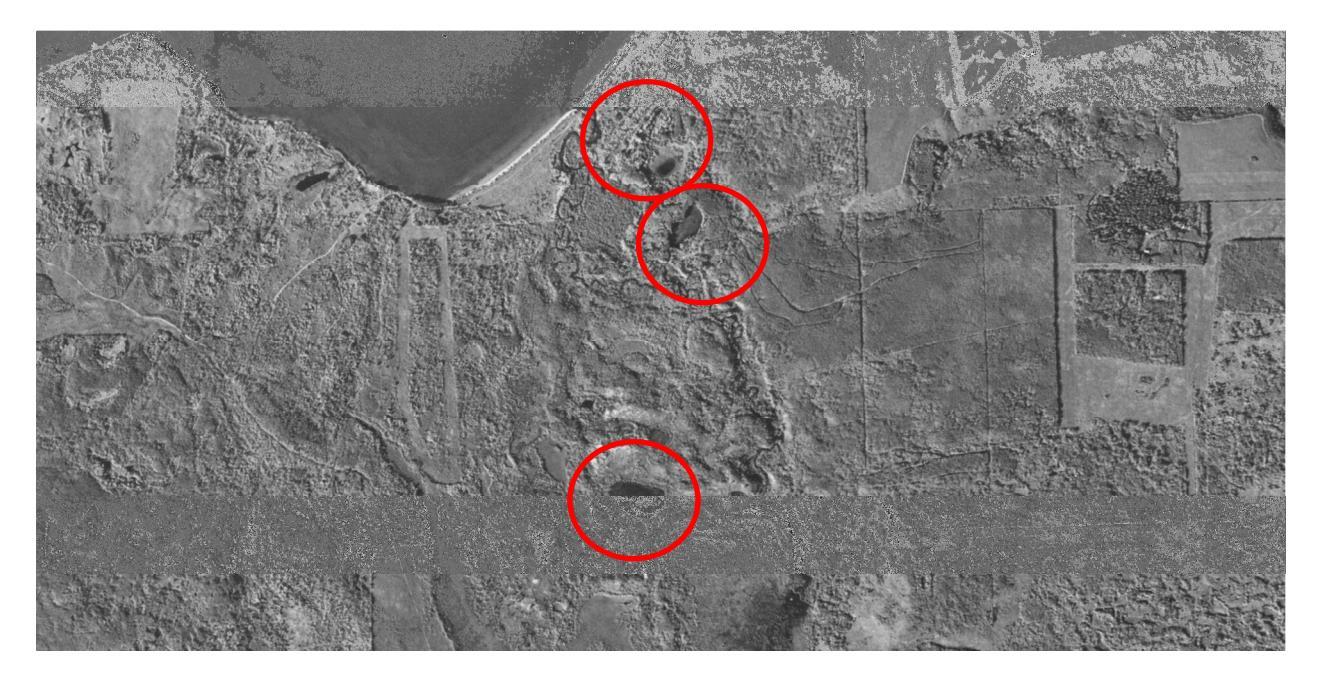
- o Culvert 27: Decreased water levels shown in three water bodies surrounding this culvert between 1959 imagery and 2011 imagery.
- o Culvert 8: Small water body shown in 1972, and is not visible in the 2011 imagery.

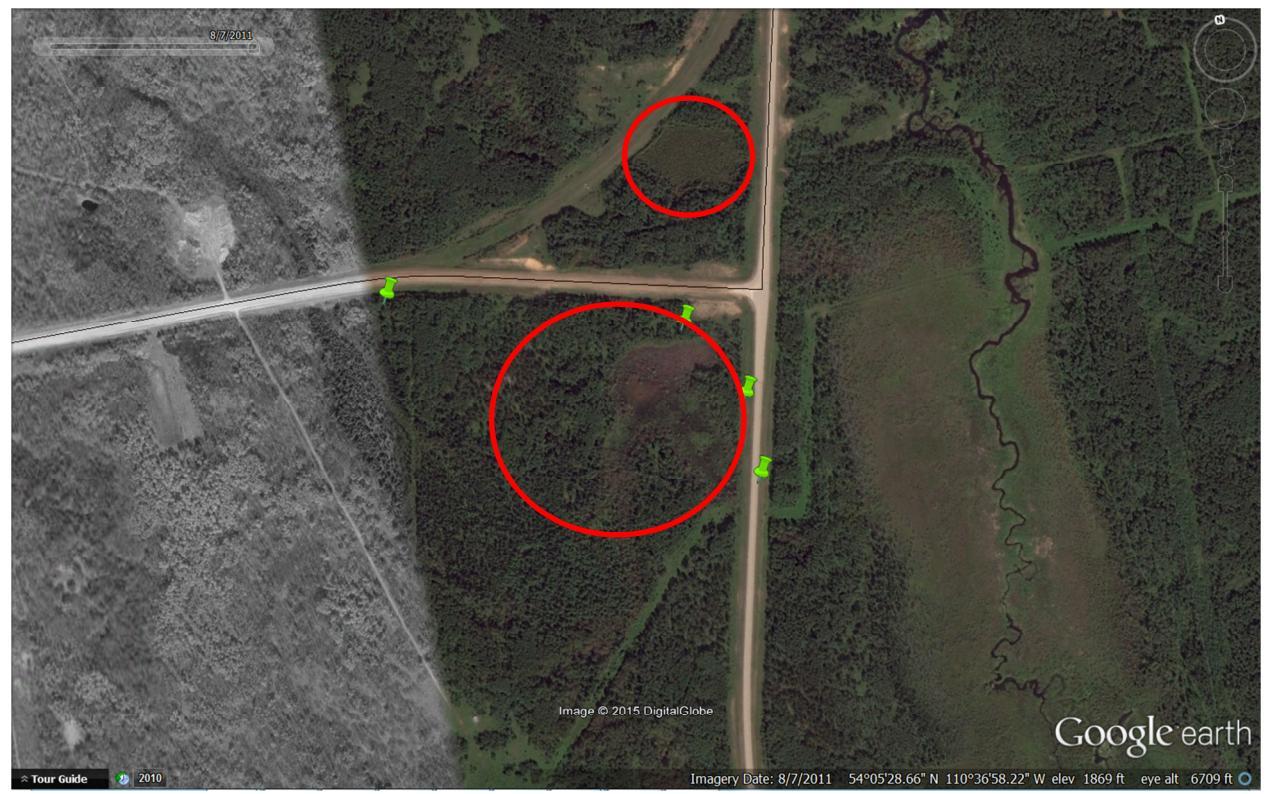
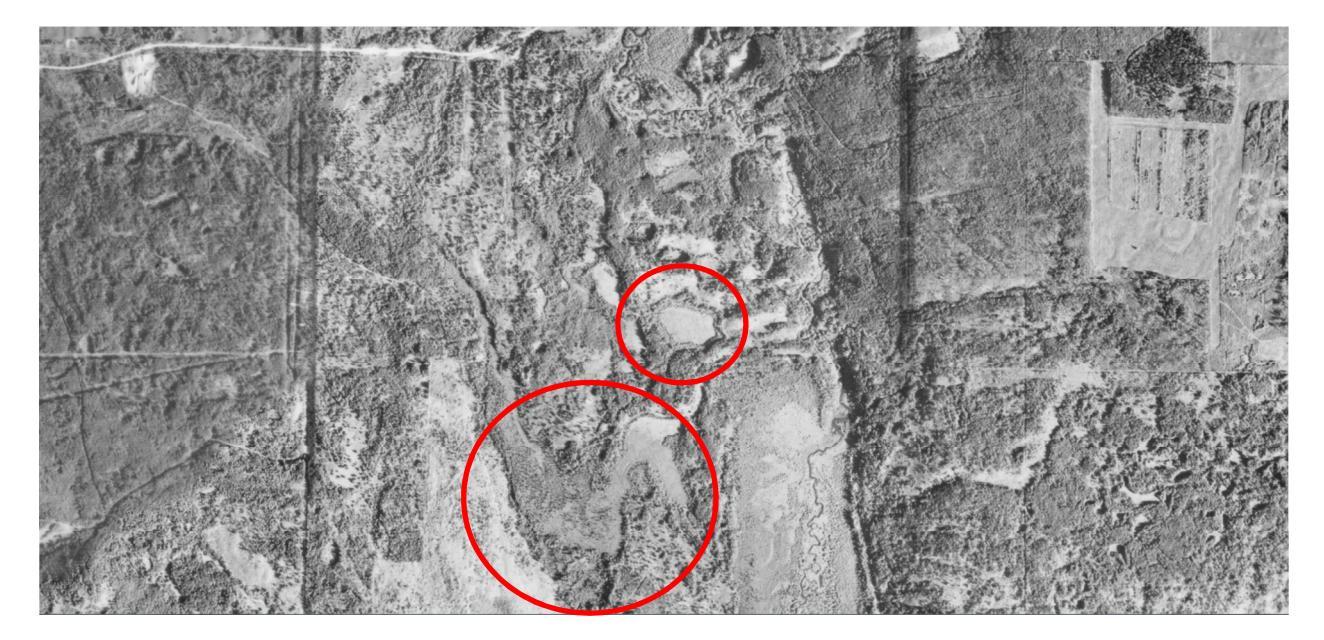
<u>Culverts 25, 26, 28, 29</u>

- o Culverts 25, 26, 28, and 29: Two small water bodies are visible in 1972 imagery, and decreased water levels are shown in the 2011 imagery.
- o Culvert 6: There is open water visible in the 1972 imagery, but not in the 2010 imagery.

26	No road visible.	<ul> <li>No road visible.</li> <li>Minimal change from 1959.</li> </ul>	<ul> <li>Reduced open water on downstream side of road.</li> </ul>	August 7, 2011	<ul> <li>Inspect for blocked or perched culvert condition.</li> <li>Check downstream end of road in spring for open-water.</li> </ul>
28	No road visible.	<ul> <li>No road visible.</li> <li>Minimal change from 1959.</li> </ul>	<ul> <li>Reduced open water on downstream side of road.</li> </ul>	August 7, 2011	<ul> <li>Inspect for blocked or perched culvert condition.</li> <li>Check downstream end of road in spring for open-water.</li> </ul>
29	No road visible.	No road visible.	Reduced open water on	August 7, 2011	Inspect for

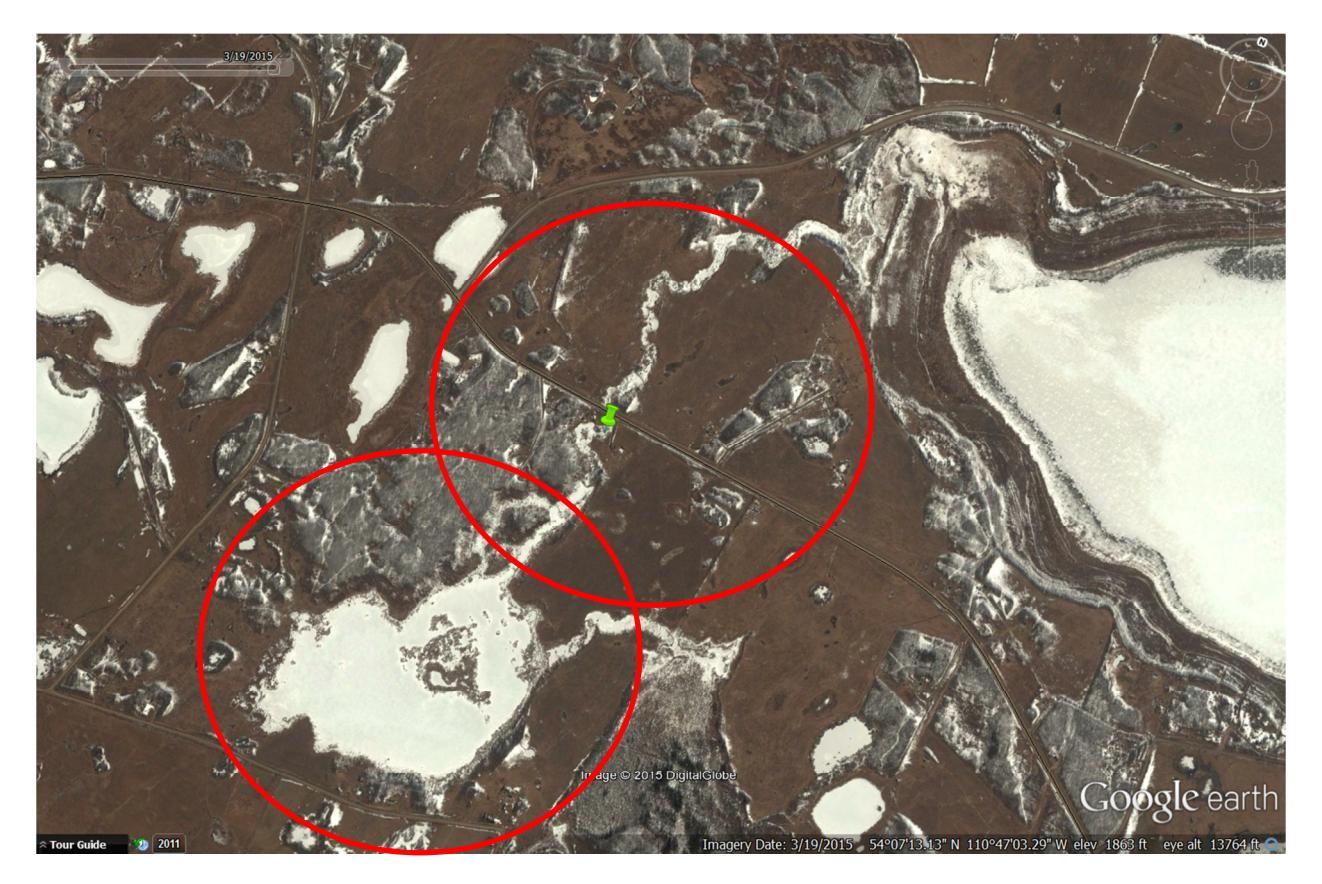
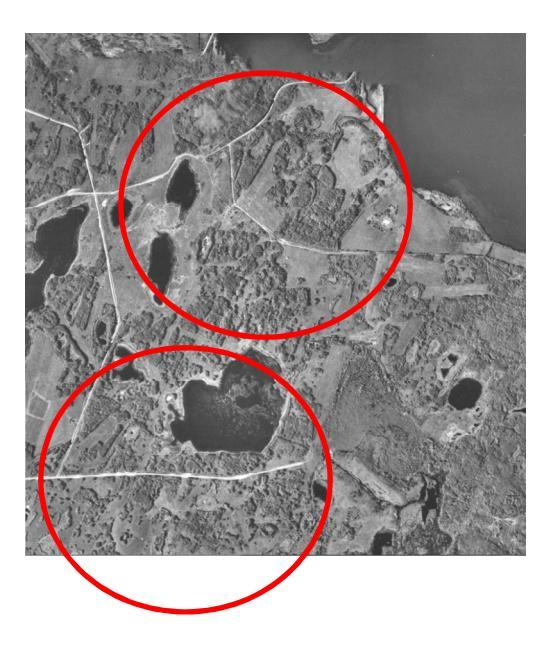
- Culvert 19: A large open water body with a defined downstream drainage is present in the 2015 imagery. In 1959 there was a smaller water body than that shown in 2015 and no defined drainage.

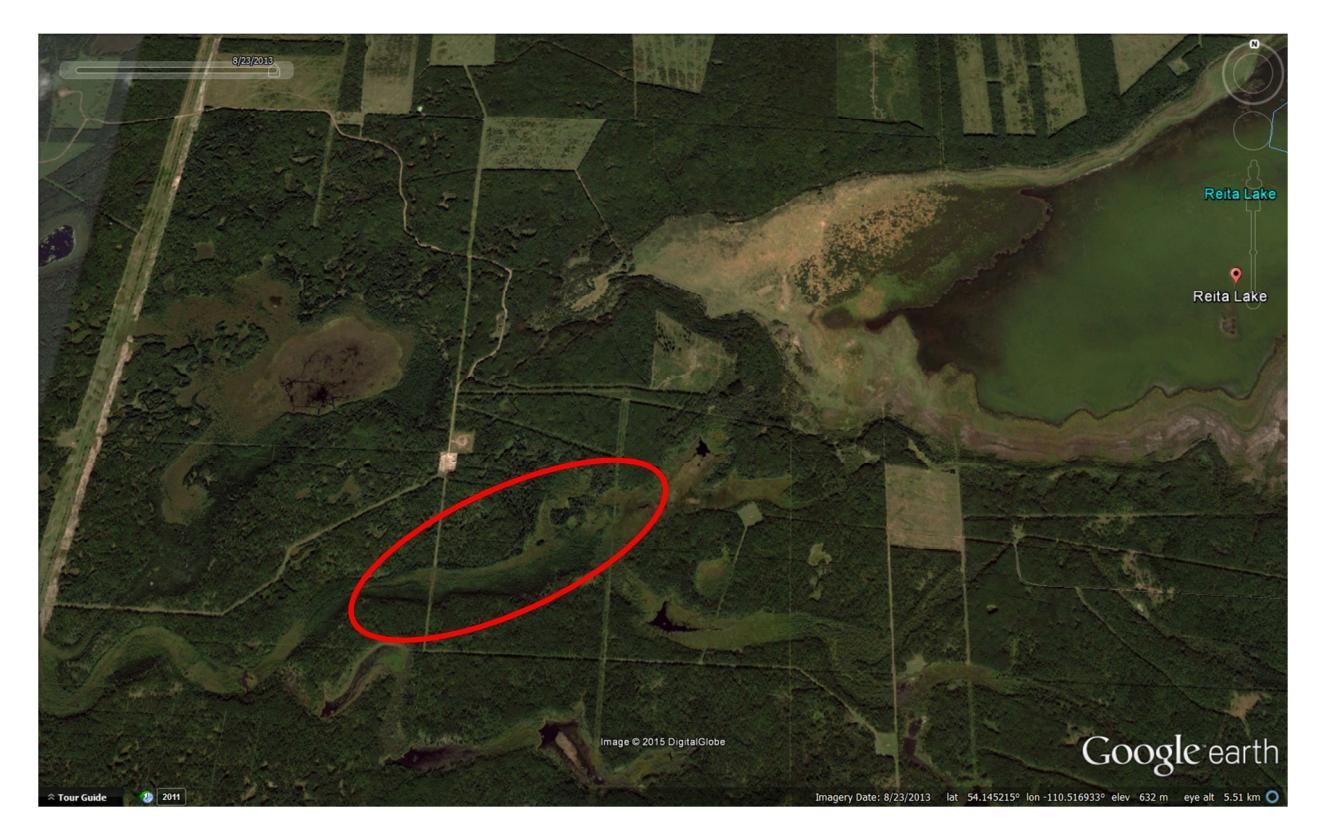
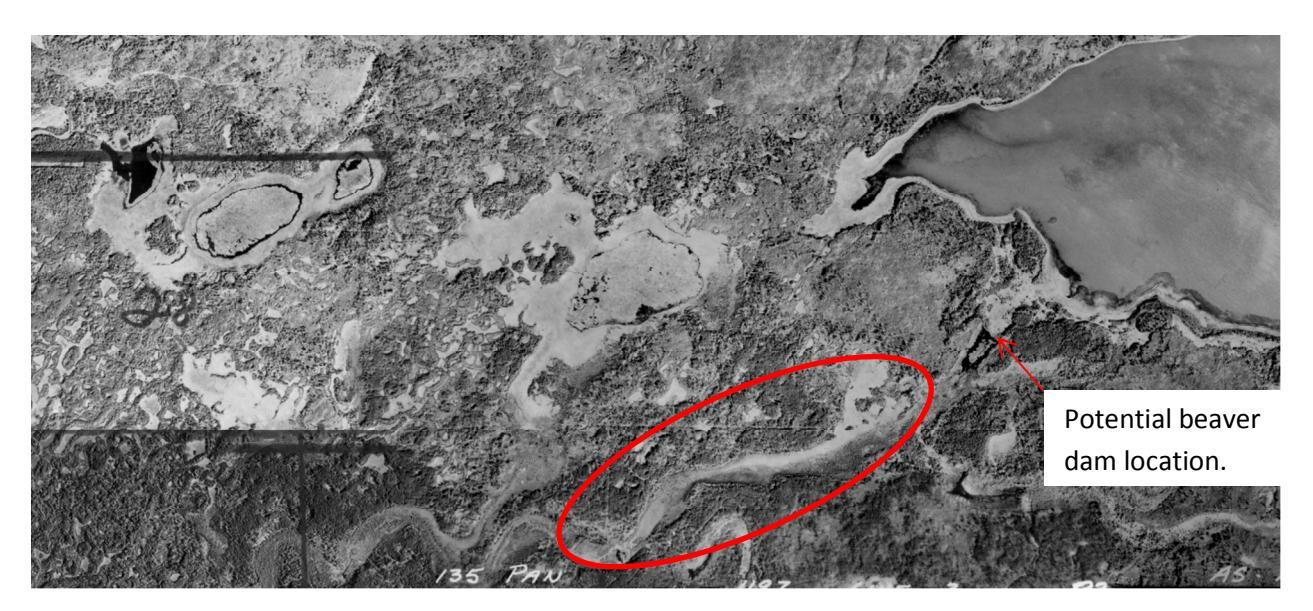
# <u>Reita Lake</u>

The area around the west side of Reita Lake is predominately flat with extensive wetlands and there does not seem to be a continuous, connected drainage toward the Muriel Lake watershed. Ponding can be seen in a wetland on the west side of Reita Lake in the 1972 imagery, which is the result of a well-established beaver dam (as shown in Appendix A). The dam construction indicates flow direction toward Reita Lake, which is consistent with DEM elevation profiles (Google Earth 2013). Although not visible in 1950 and not covered in the extent of the 1959 imagery aerial imagery between 1960 and 1970 may be able to help establish the direction of the drainage prior to the beaver dam. Email correspondence with MLBMS indicates that imagery of Muriel Lake is available for 1962 from the U of A, however it is unknown whether there is coverage for Reita Lake. Additional imagery for Reita Lake may be available for purchase from the Government of Alberta (1967; Table 1). Unless the above imagery suggests a compelling reason to believe drainage at these times was oriented towards Muriel Lake, Matrix suggests that there is not a strong case for the Reita Lake ditch being a major factor in the decline of Muriel Lake water levels. Instead, Matrix suggests that further efforts be channeled to the recommendations in Section 4.
