# MURIEL LAKE BASIN HYDROLOGY STUDY – PHASE 2

Peter Cordingley Muriel Lake Basin Management Society 9607 83 Street NW, Edmonton AB T6C 3A3

November 24, 2021

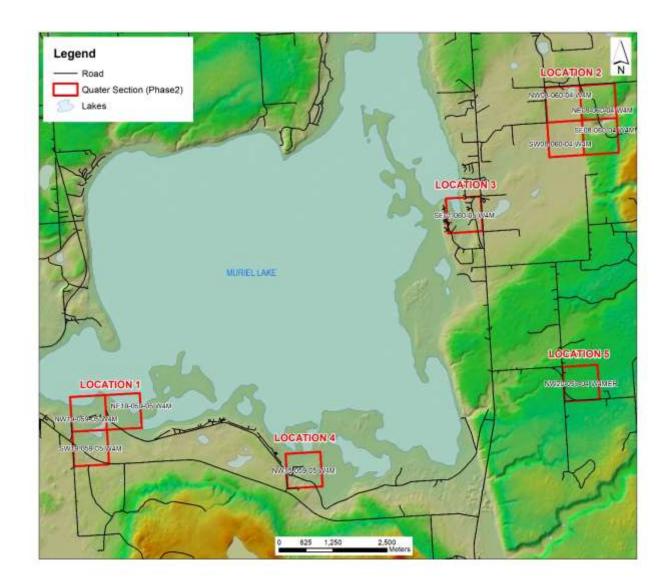
FIGURE 1. Distribution of locations of concern identified in the surface disturbance study

For this study, the Client provided to Solstice five locations of concern. Table 1 summarizes the quarter section location, location name, and description. Figure 1 presents the distribution of the locations to be investigated in the study.

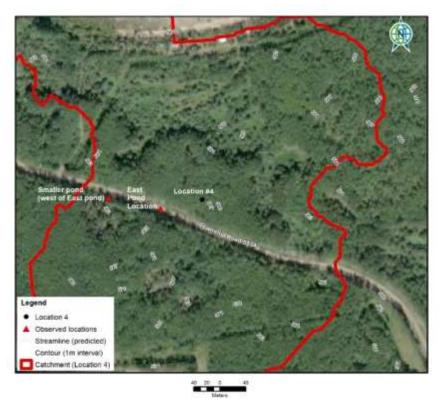
FIGURE 2. Map showing the sites visited at Location #4

Although the profile analysis results for Location #4 indicated that the predicted streamline had no significant impoundment, ground-truthing investigations revealed a roadside ditch west of Location #4. The field locations visited were the east pond location (Longitude: -110.67633 degrees, Latitude: 54.10291 degrees) and a smaller pond – farther west (Longitude: -110.67722 degrees, Latitude: 54.1031 degrees) were visited (Figure 2). Figure 3 shows the east ponded water location at Location #4, which appeared to have a buried culvert that impounds water flow.

The elevation of the roadside ditch location (i.e. smaller pond – farther west) relative to the surrounding landscape was higher, resulting in an obstruction to water flow uphill to the east. Based on the field observations by MLBMS, it is suggested that deepening the ditch on the upstream (southern side of the road) be performed. To the north of the east pond location, it was observed that some clearing and deepening is necessary to aid water flow beyond the fenceline north of the site.

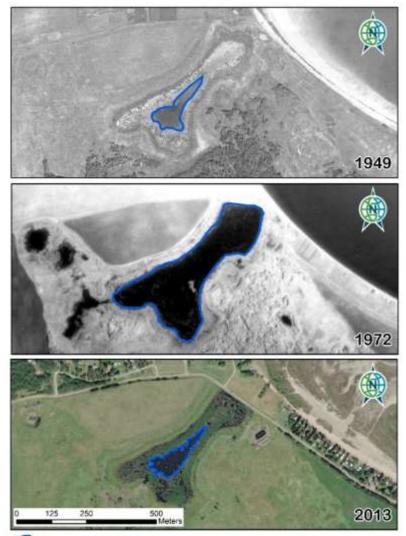
#### FIGURE 4. The spatial extent of water-covered land in Location 1 for 1949, 1979, and 2013

A review of historical aerial photographs for Location #1 indicates that the wetland basin of interest has been present since 1949. No direct connectivity is apparent between the wetland basin of interest and Muriel Lake. However, the lake may have some groundwater influence on the wetland basin in wet years with high precipitation, as indicated in the 1972 photo (see Figure 4).

The results showed that for Location #1, the spatial extent of water-covered land was approximately 1.1, 9.1, and 1.1 hectares in 1949, 1972, and 2013 respectively. The surface water area of the slough experienced a drastic increase of roughly 8 hectares between 1949 and 1972 and declined to 1.1 hectares in 2013. Figure 4 shows the changes in the spatial extent of water-covered land in Location #1.

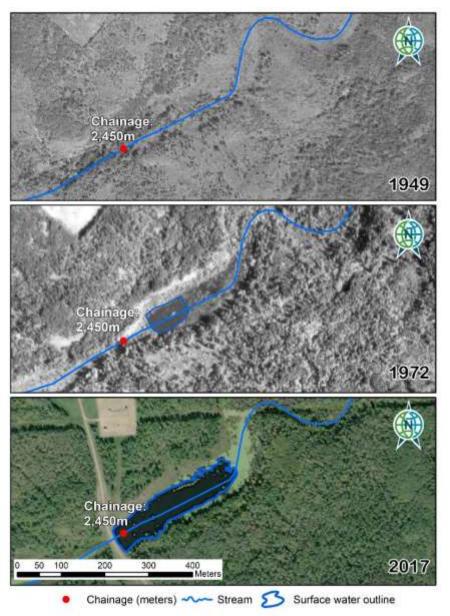
FIGURE 5. The spatial extent of water-covered land in Location #2, upstream of chainage 2450 meters on ML6, for 1949, 1972, and 2017.

The review of the historical air photos (1949 and 1972) and the recent high-resolution World View imagery (2017) revealed that the surface water upstream of the crossing (chainage 2450m along ML6) was 0.5 hectares in 1972 and 1.9 hectares in 2017 (a change of approximately 1.4 hectares). In 1949, there was no surface water activity upstream of ML6 at chainage 2,450 meters (see Figure 5).

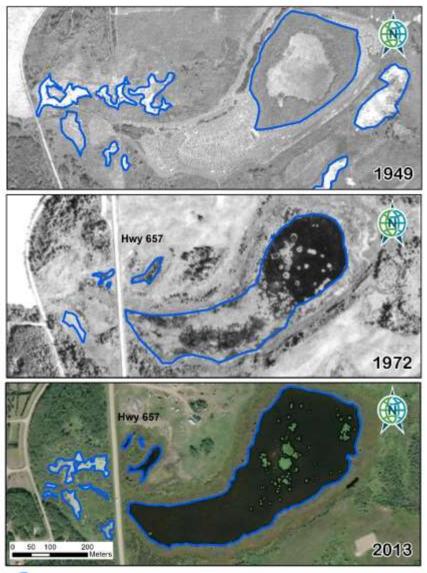
Over the period investigated (1946, 1972, and 2013), Location #4 experienced increased water impoundment. The interpretation of the historical air photos and high-resolution imagery revealed that the surface area of the waterbody east of Hwy 657 was 6.4 hectares (1949), 9.4 hectares (1972) and 11.6 hectares (2013), respectively (Figure 6). Post-construction of Hwy 657 in 1972, the slough to the west of the highway experienced some fragmentation from its initial form indicated in Figure 6.

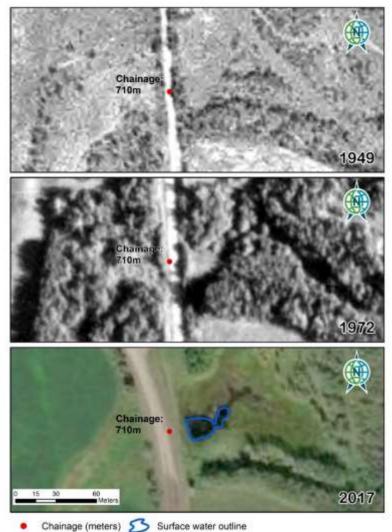
FIGURE 7. Historical air photographs (1946 and 1972) and recent high-resolution satellite imagery (2017) showing the "Holyoke" ponded water (Location #5).

For Location #5, the identified ponded water upstream of the road crossing at chainage 710 meters on the Muriel lake (ML) 3-1 present in 2017 was none existent in 1949 and 1972, respectively (see Figure 7). For this location of concern, the ponded water was a recent development based on historical records as shown in the aerial photographs (Figure 7). Hence, there was no change in the extent of water-covered land in this location of interest. Appendix G presents the historical air photo maps generated in the study.
