MURIEL LAKE BASIN HYDROLOGICAL NETWORK PROJECT

Prepared for:

Peter Cordingley
Muriel Lake Basin Management Society
9607 83 Street NW,
Edmonton AB T6C 3A3

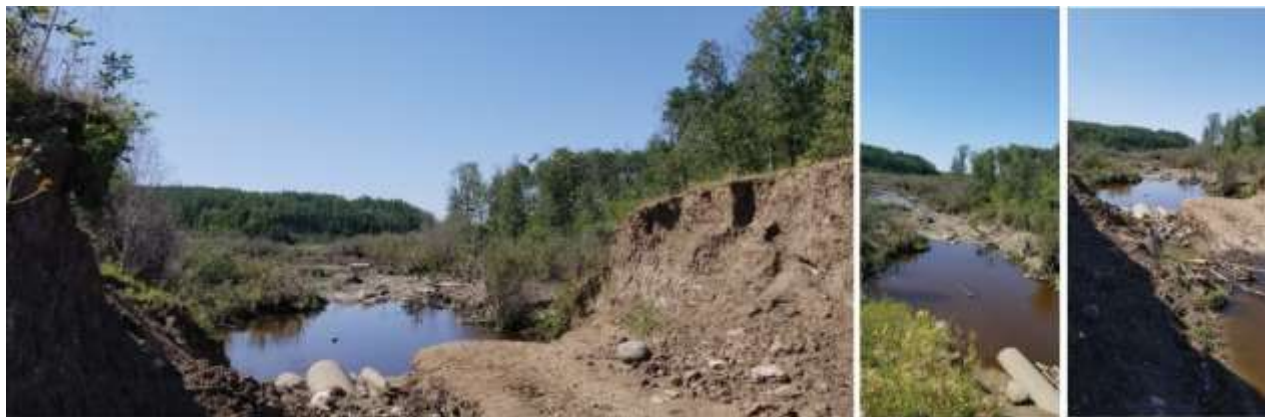
FIGURE 6. Field verification photograph showing confirmed beaver activity resulting in obstruction to water flow along stream segment ML6 analyzed in the study

Based on the results obtained, impounded locations requiring immediate attention were identified due to small beaver dams or blocked culverts. For example, obstructions to water flow on the stream segment ML6 were identified at chainages 480 m, 620 m, and 2,480 m, respectively. The obstacle at chainage 2,480 m was an access road leading to an abandoned oil well site, remediation of which has been assigned to the Orphan Well Association (OWA). Beaver's activity in this area is extensive, and MLBMS report that blockage of culverts had previously required mechanical clearing of the culverts by the operating oil company and, more recently, OWA. In July 2020, MLBMS provided drone imagery, which showed that the road had washed out, and the culverts were destroyed. Figure 6 shows field verification photos of the obstructions to the river segment ML6 evaluated in the stream analysis. A segment of the culvert is visible far downstream, and there is evidence of beaver activity to dam the breach. This location is identified for immediate management action.
